FIELD CHANGE ORDER

Reference No. : 00 135 016
Date : August 2001
Product Group : 742

OPTIMUS 50 / 65 / 80

Error 00TH during tube adaptation

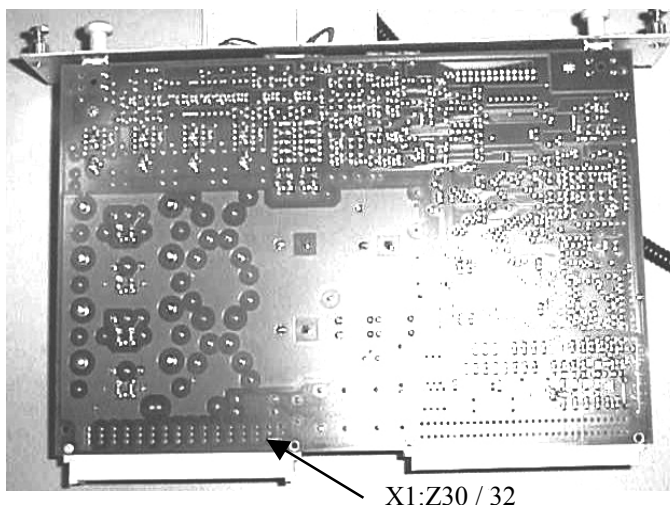
Symptom : Error 00TH during tube adaptation
Cause : The optocoupler B2 operates at its tolerance limits on board of PCB mA control EZ 119 (4512 108 05948). This can lead to intermittent problems during tube adaptation.
Remedy : Reduction of the input current for the optocoupler by soldering on an additional resistor parallel to the optocoupler diode.

1. Switch off the generator.
2. Open the cabinet, wait at least 1 minute, then pull out PCB EZ 119.
3. Solder on the resistor between contacts X1:B30 or Z30 and X1:B32 or Z32, see sketch for details.
4. Reinstall the PCB in the generator rack.
5. Close the cabinet.
6. Test all applicable functions.
